## FINAL REPORT

### ELEVATED TEMPERATURE STRESS CORROSION OF HIGH STRENGTH SHEET MATERIALS IN THE PRESENCE OF STRESS CONCENTRATORS

Contract NASr-50

**MECHANISM OF HOT SALT STRESS  
CORROSION CRACKING OF TITANIUM BASE ALLOYS**

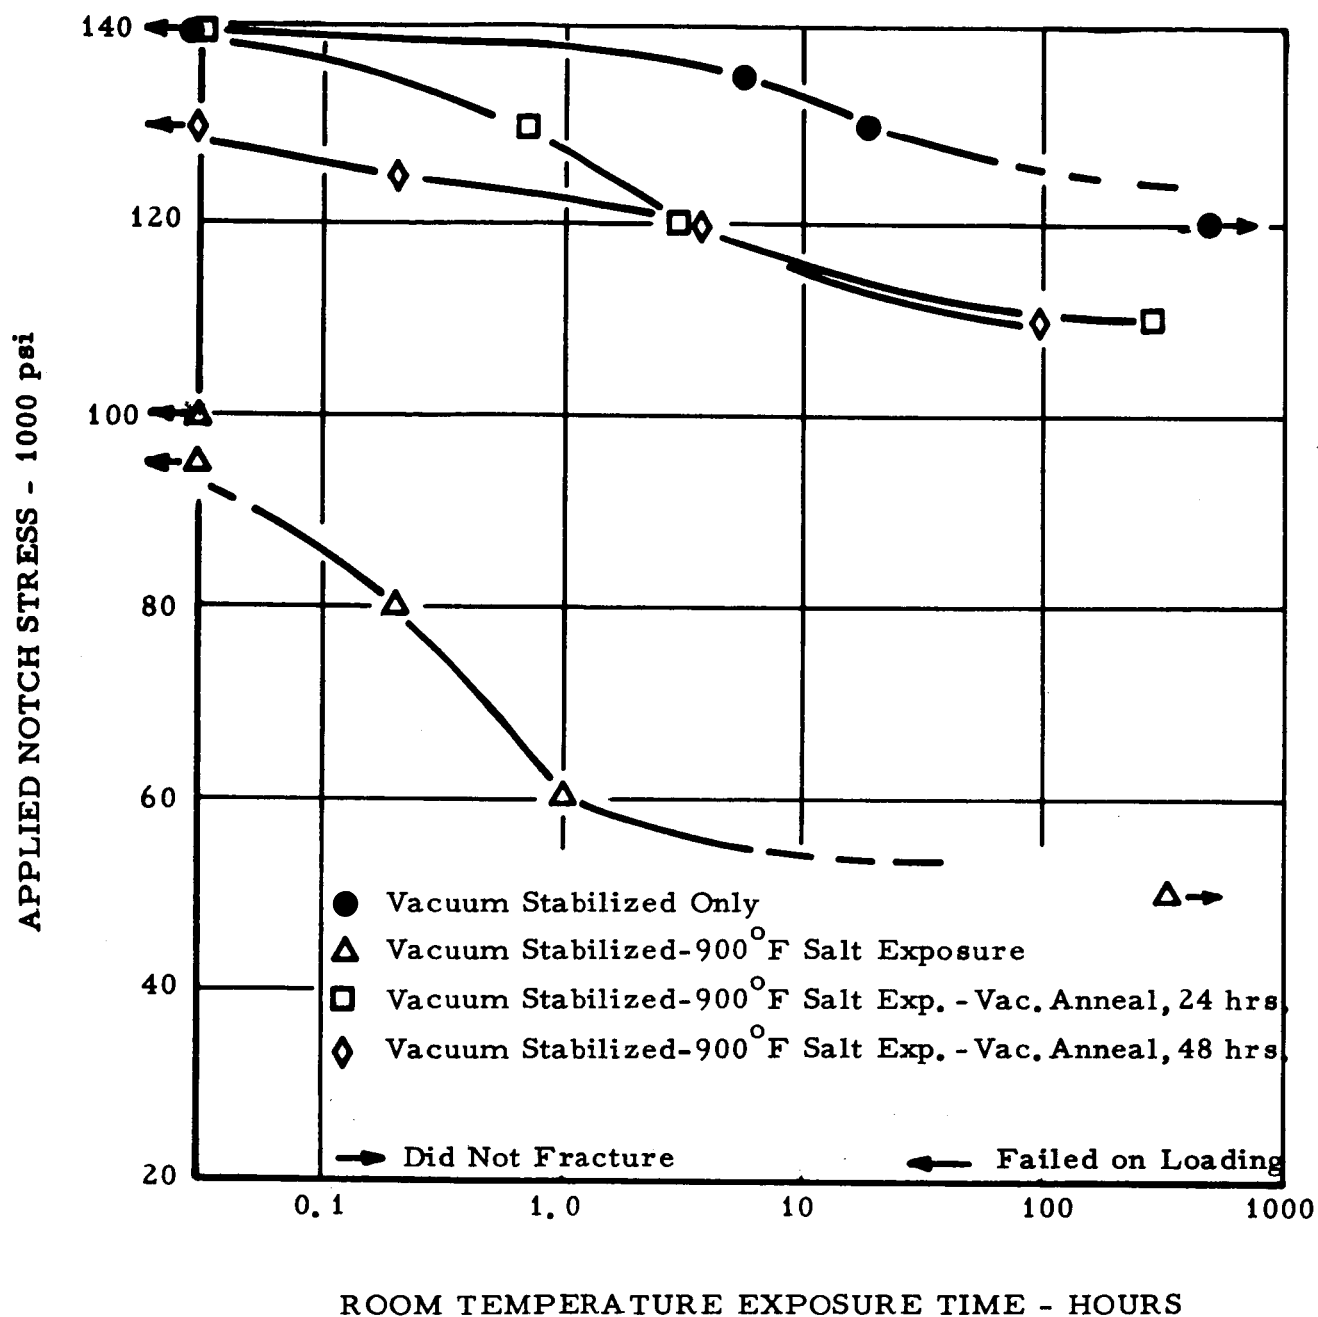
Fig. 16 THE EFFECT OF VACUUM ANNEALING AFTER SALT EXPOSURE ON THE SUBSEQUENT ROOM TEMPERATURE DELAYED FRACTURE OF Ti-8Al-1Mo-1V.

These test results would indicate that hot salt stress corrosion cracking is indeed a manifestation of hydrogen embrittlement. If this is the case, the embrittlement should be eliminated by inserting a vacuum annealing treatment between the elevated temperature salt exposure and the room temperature stress exposure. To ascertain whether or not this were the case, specimens were salt exposed exactly like the 900<sup>o</sup>F specimens in Fig. 14. The vacuum stabilizing treatment inserted prior to room temperature stressing was also identical with that done prior to salt exposure except that some of the specimens were annealed 24 hours and others 48 hours. As shown in Fig. 16, the inserted anneal did indeed result in a recovery of properties supporting the thesis that embrittlement is caused by absorbed hydrogen.
